Intel[®] Virtual RAID on CPU (Intel[®] VROC) 8.0 PV Release for Eagle Stream

Customer Release Notes

November 2022

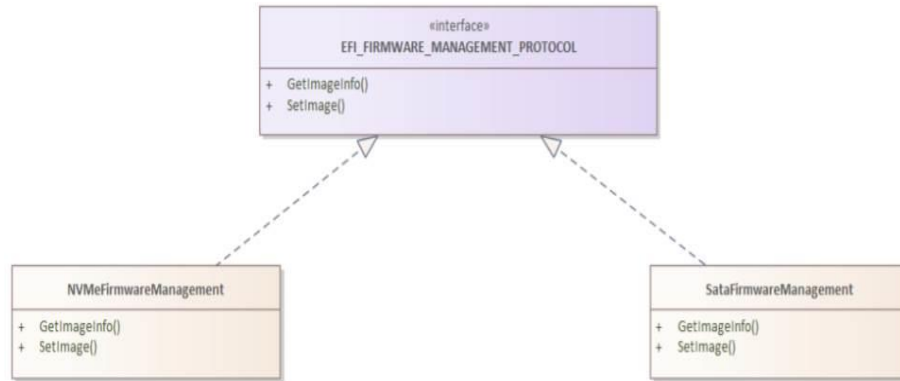
The following diagram highlights the process flow to support both NVMe and SATA drives.
